Manhole Inspection Summary

Manhole # S27K__017MH

Location Address: **834 Washington Ave**

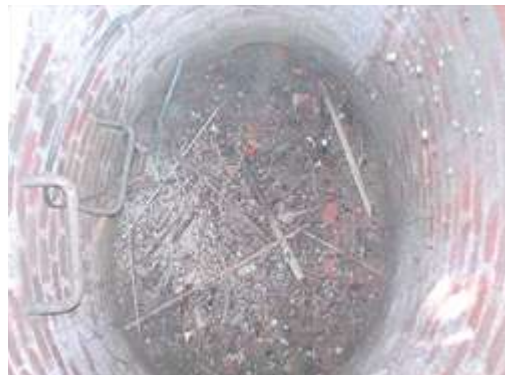
Top View

Top view shows terminal and debris in mandhole

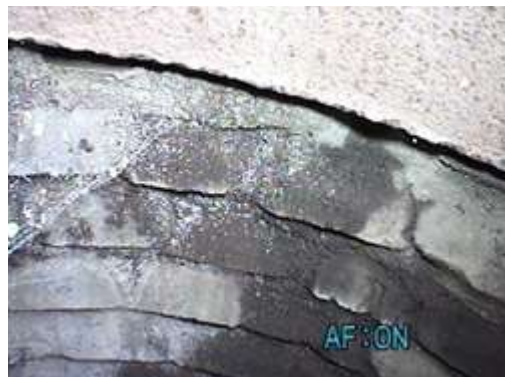
Defect 6

Infiltration: ☐ None ☒ **Joint** ☐ Cracks ☐ Mortar ☐ Roots ☐ Wall

infiltration in joint between frame and chimney

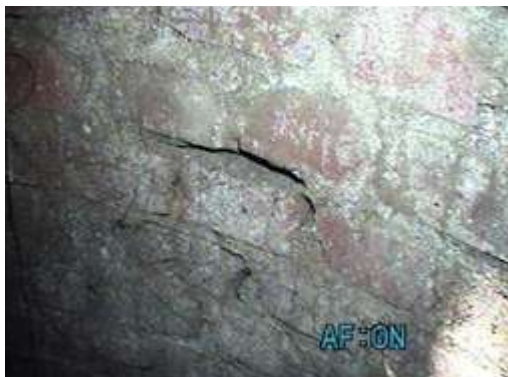
Defect 5

missing mortar in barrel

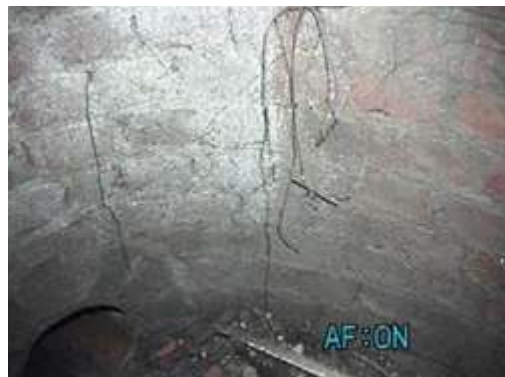
Defect 4

Condition: ☐ Sound ☐ Cracked ☒ **Root Intrusion** ☐ Loose Brick ☐ Deteriorated

root intrusion

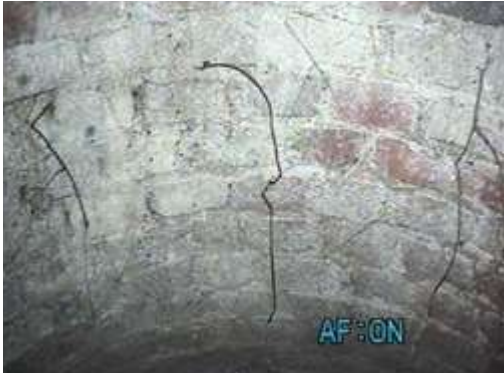
Defect 3

root intrusion

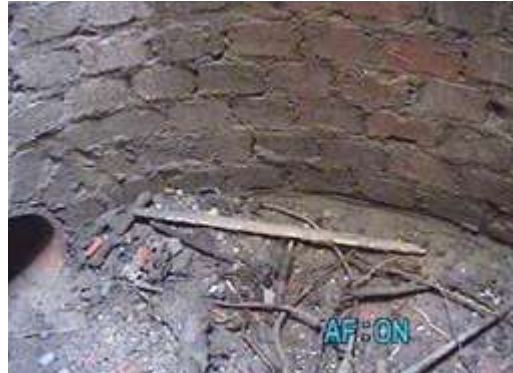
Defect 2

Condition: ☐ Sound ☐ Cracked ☐ Root Intrusion ☐ Deteriorated ☐ Leaks ☒ **Debris**

debris in channel

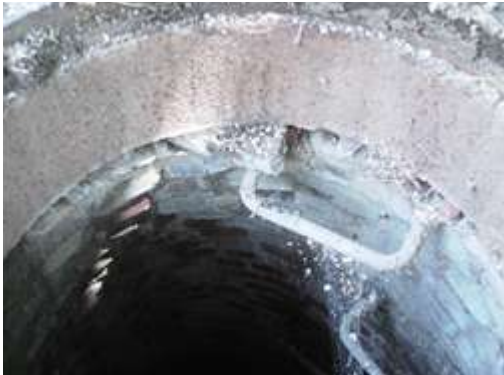
Defect 1

Condition: ☐ Sound ☐ Cracked ☐ Root Intrusion ☒ **Loose Brick** ☐ Deteriorated

loose bricks in chimney

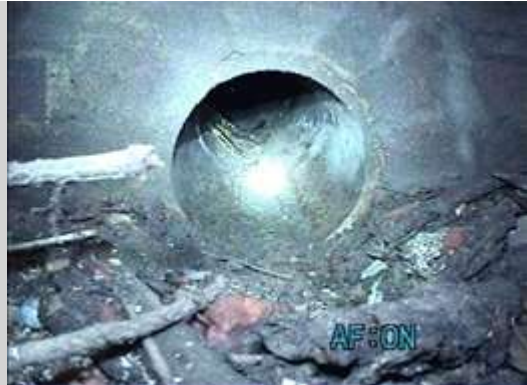
12 O'Clock Outflow

8 in. Circular Gravity Sewer
Pipe Out @ 12 O'Clock

Infiltration: **None** Pipe Seal Cond: **Sound**
